# Futur*Hist*

## Energy Retrofits in Historic and Traditional Buildings

# Typology 4 - Willa miejska / Polish garden city/urban villa (1900 - 1945)

## Kraszewskiego 22

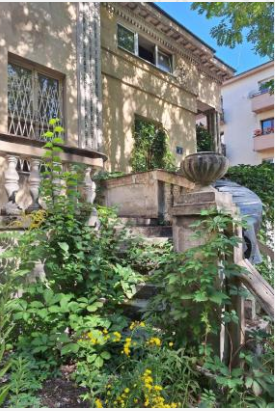
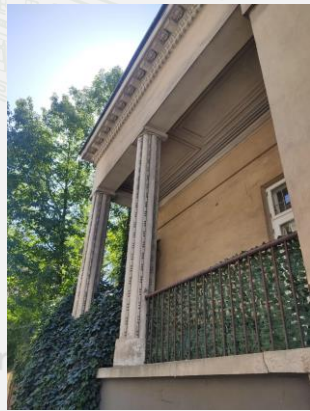
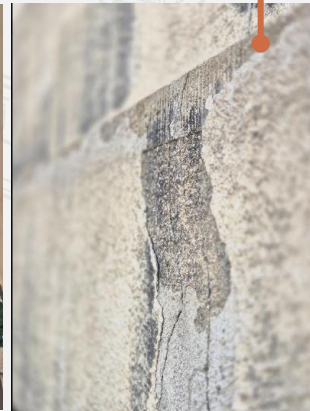
Ornamental  
frieze

decorative  
columns

High plinth  
mineral/lime  
plaster

rectangular  
windows  
doors

pilasters  
horizontal  
divisions

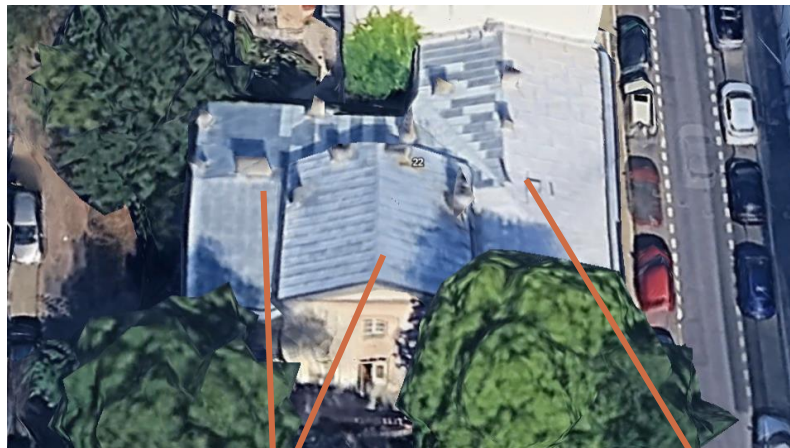
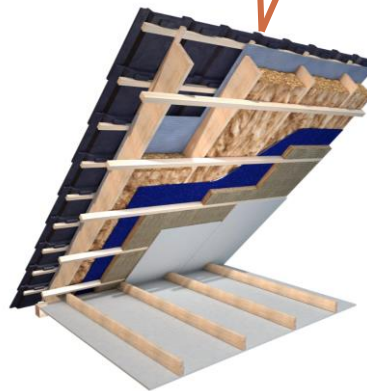
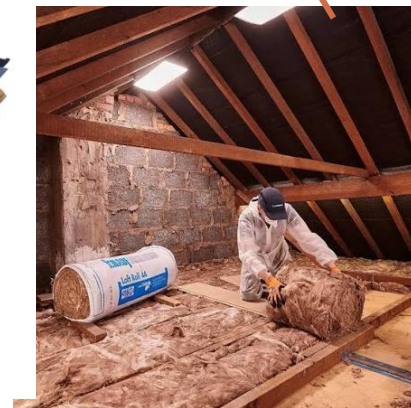
## "Roof Insulation - Cold Roof"

*The solution is acceptable according to the Conservation Office's guidelines. Any alterations to the roof that would change its external appearance are not permitted, and the chosen solution would not raise the level of the roof and would not affect the roof drainage system and proportions of the roof facades, and the change wouldn't be actually visible from the street level. Insulation will be applied between rafters and above it with supporting elements and a plasterboard finish.*

*Another solution is considered – to place the insulation on top of the attic floor, closing off the heated space of the flats and communication areas from the unheated attic.*

| U-value<br>before the intervention | U-value<br>after the intervention |
| 5.5 W/m <sup>2</sup> K | 0.14 W/m <sup>2</sup> K |

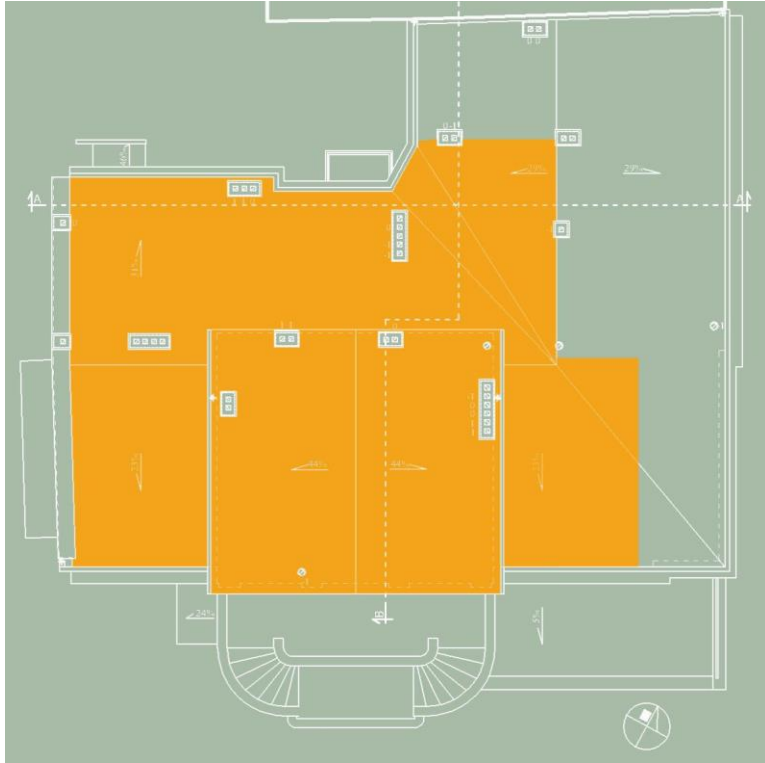
Roof Plan – Shows Pitched Roof  
Insulation

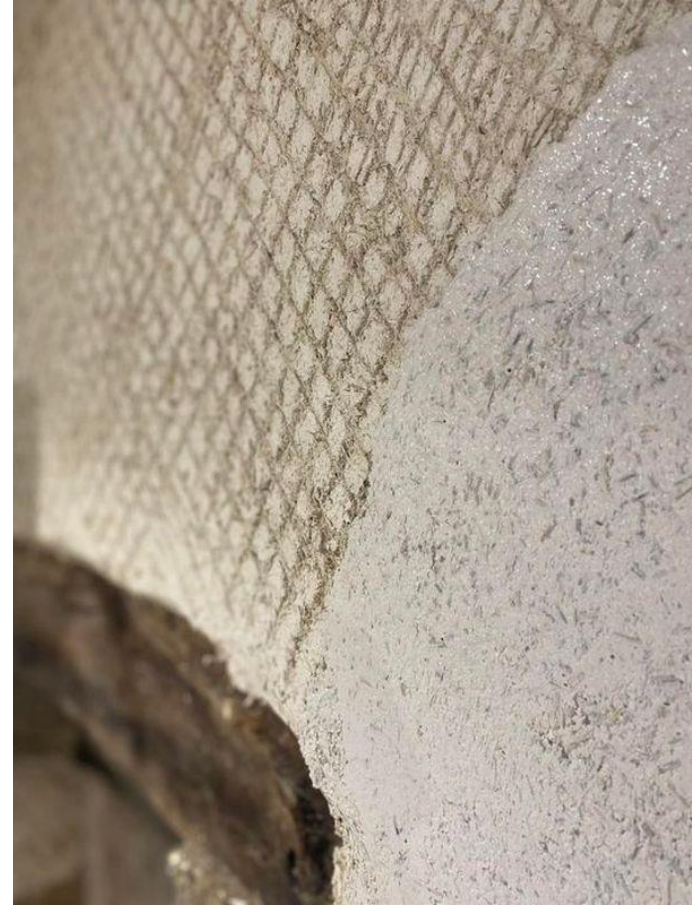
# "External Wall Insulation (EWI) - Insulating Plaster"

*Thermal insulating plaster (TIP).* It can improve both thermal and acoustic properties of the building.

- **Breathable**
- **Traditionally looking**
- **Eliminate thermal bridging and thermal leaks** if applied in a continuous coat
- **Resistant to moisture** (depending on composition)
- **Much healthier** option than many other alternatives

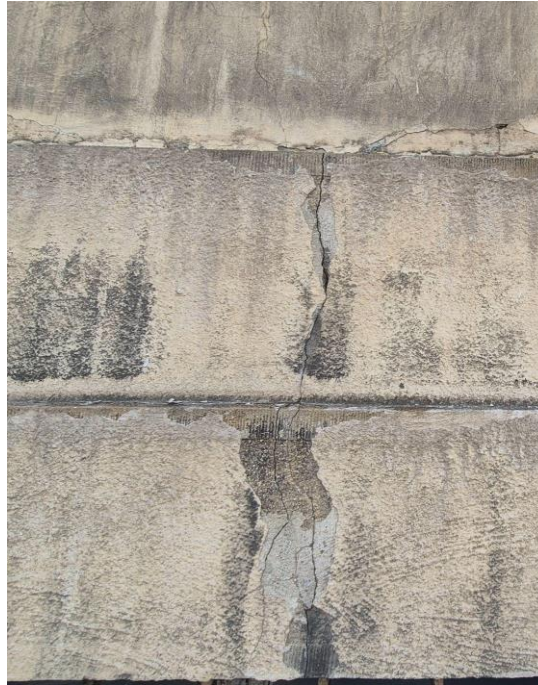
Lower part of front facade: Remove cement render, repair historic lime plaster, and restore missing decorative elements.

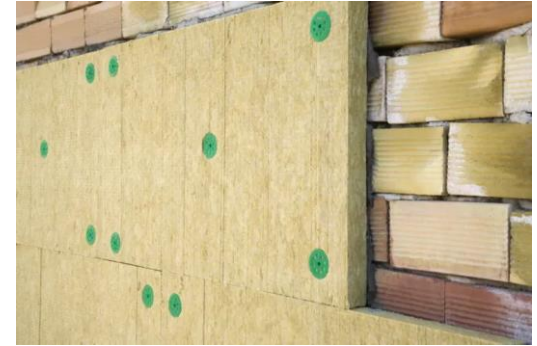
*The solution needs to be carefully calculated and carried out to avoid moisture condensation in the barrier or between the layers. Moisture levels should be monitored after the installation.*

*The change of the temperature on the external surface of the wall should be monitored as well to assess if the works influence the decorative details on the facades.*

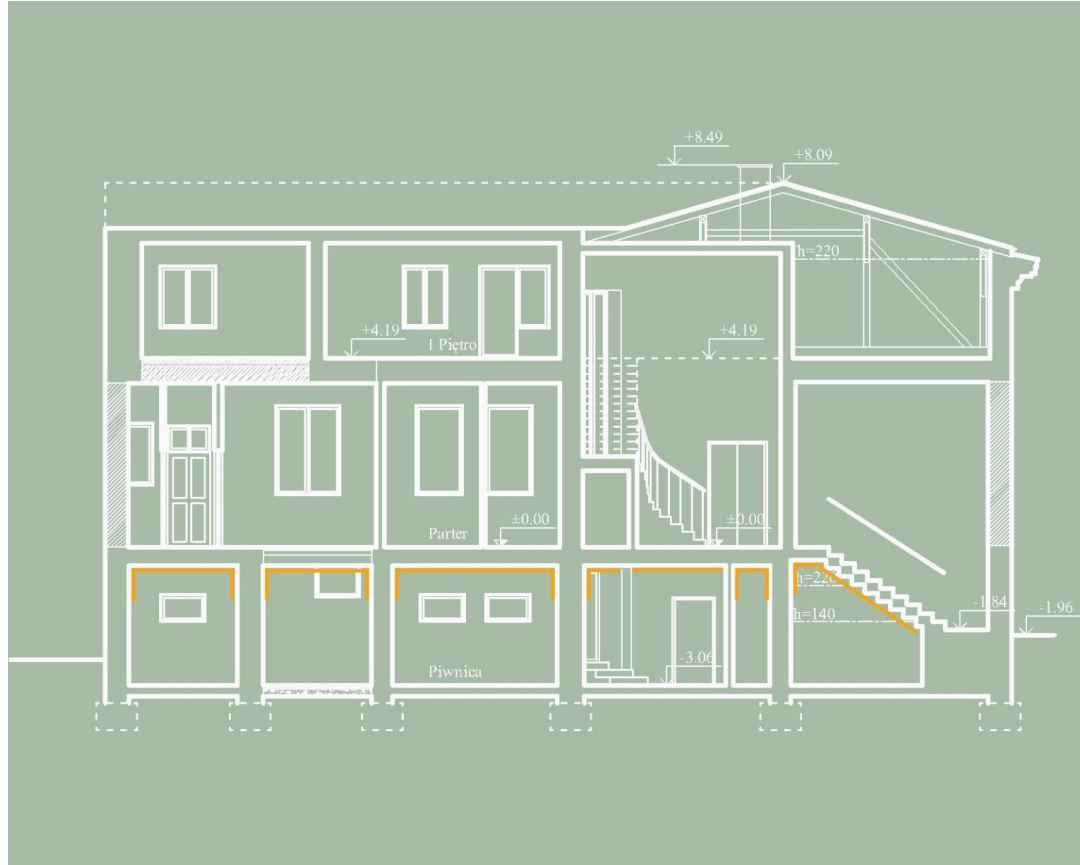
AA SECTION

**150 mm** insulation boards fixed to the underside of the existing reinforced-concrete floor slab.

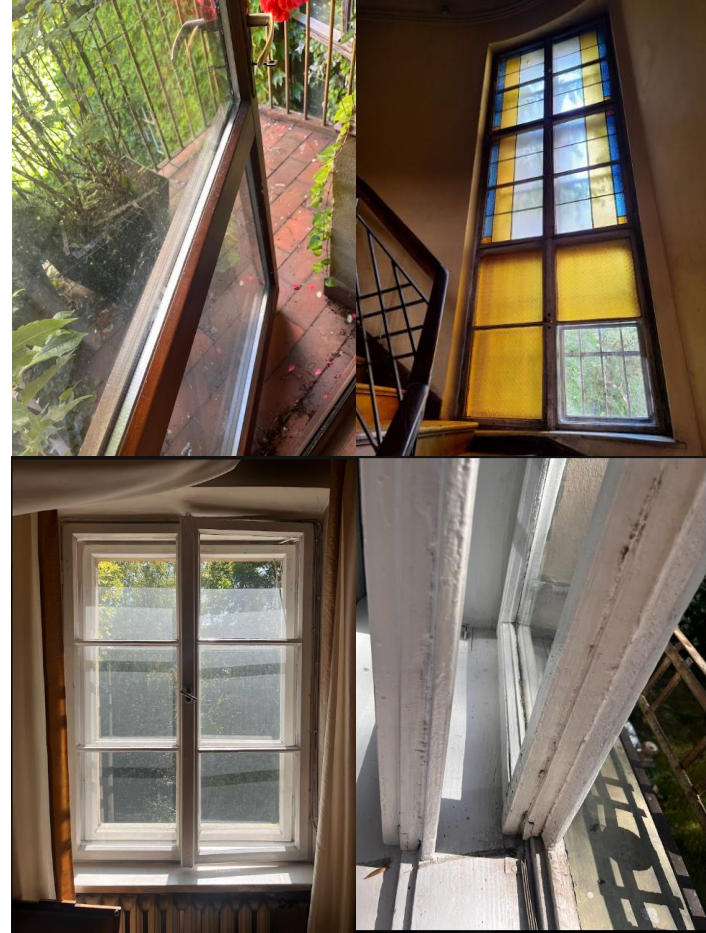
# "Window repair and glazing replacement"

- **Single window – single** sash timber casement with historic single glazing. 4 cm thickness of the timber frame and 3 mm of single glazing.
- **Double box** (the majority) is two identical single-glazed timber sashes separated by a 6–8 cm air cavity. 4 cm thickness of the timber frame and 3 mm of single glazing.
- **Opaque openings** are in average solid 45 mm timber panels.
- **Some modern additions**

**Restraints on the Windows.** Original windows may only be replaced if they are in poor condition; if repairable, they must be conservatively restored and cannot be replaced (exterior **only?**).

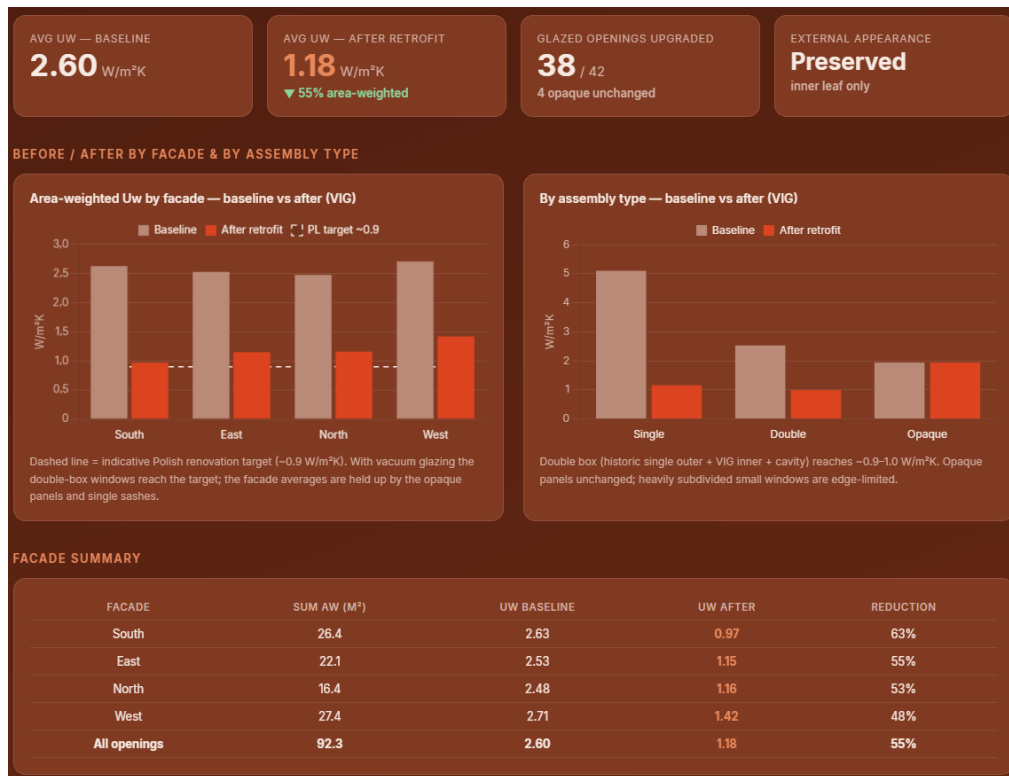
# "Window repair and glazing replacement"

- **Re-glazing the inner sash alone with a 6 mm vacuum glazing unit** – leaving the outer historic sash untouched – preserves the external appearance entirely and respects the profile-thickness restriction that would otherwise rule out heavier glazing.
- **Repair timber frames**
- **Additionally, we propose to change the glazing in the staircase window to complete the coloured/tinted glass frame, as on the window above the main entrance.**

The solution needs to be accepted by the Conservation Office and carried out by experienced craftsmen.

- **Low to no MATERIAL, VISUAL AND SPATIAL change.**
