# Energy Retrofit Report:

## 5, Syrokomli Street, Kraków, PL

**FuturHist** Summer Academy 9-13 September 2026

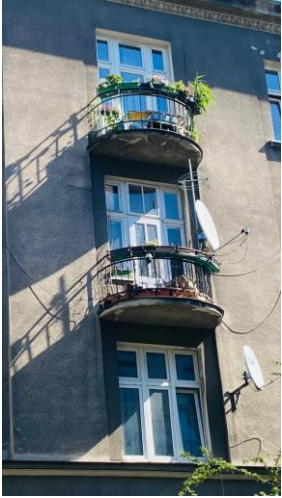
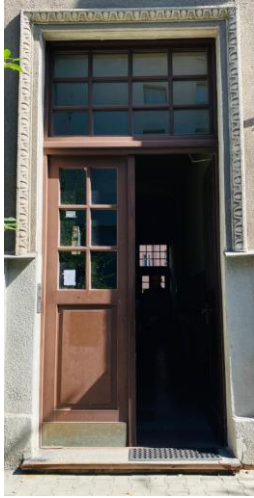
**External:** Windows + Doors

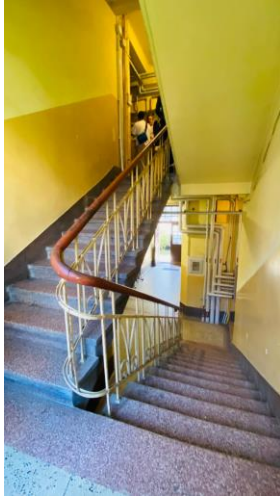
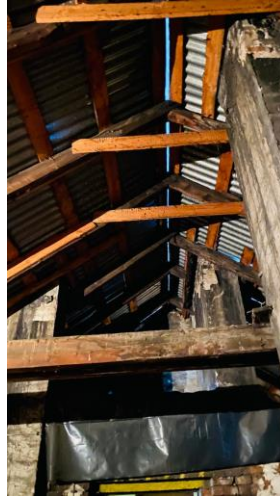
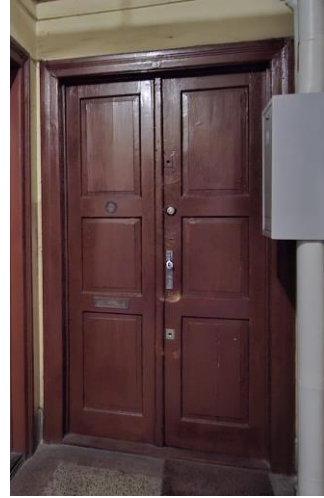
**Internal:** Stairs + Iron balustrade + Timber roof structure + Doors + Windows

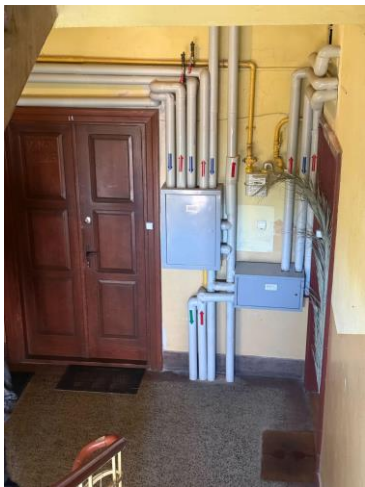
KRAKOW - BUILDING SECTION

# Energy Improvement Strategies
